# Manhole Inspection Summary

Manhole # S21WW1022MH

**Location** Address: **44 OLMSTED GREEN CT**

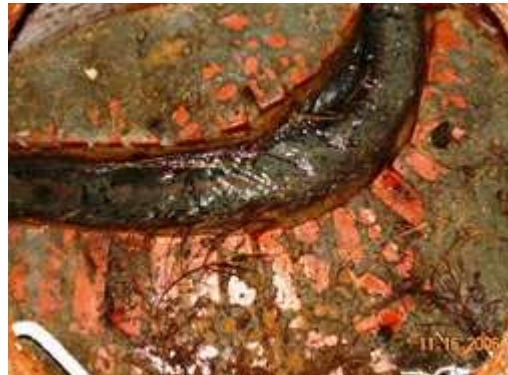
Top View

Barrel root intrusion. Evidence of surcharge - Bench debris.

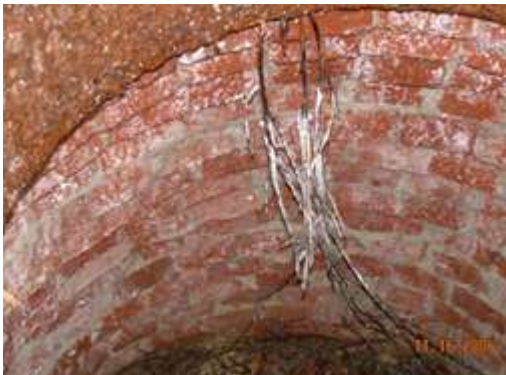
Defect

Condition: ☐ Sound ☐ Cracked ☒ **Root Intrusion** ☐ Loose Brick ☐ Deteriorated

Infiltration: ☐ None ☒ **Joint** ☐ Cracks ☐ Mortar ☒ **Roots** ☒ **Wall**

Infiltration: ☐ None ☐ Joint ☐ Cracks ☐ Mortar ☒ **Roots** ☐ Wall

Corbel and Barrel root intrusion and infiltration.

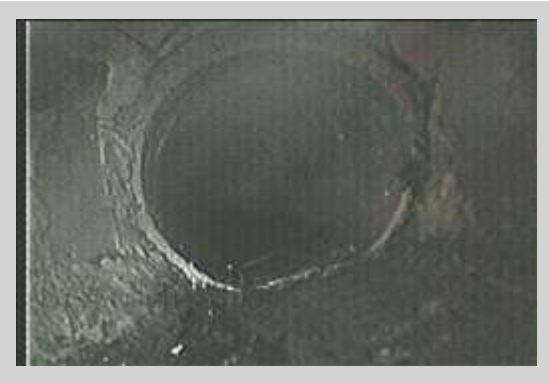
### 8 in. Circular Gravity Sewer Pipe Out @ 12 O'Clock

Deposits: ☐ None ☒ **Mud** ☐ Sludge ☒ **Debris** ☐ Grease

Silt Depth: **0** (in.) Deposits Extent: **Light**

Infiltration: **Evidence** Pipe Seal Cond: **Roots**

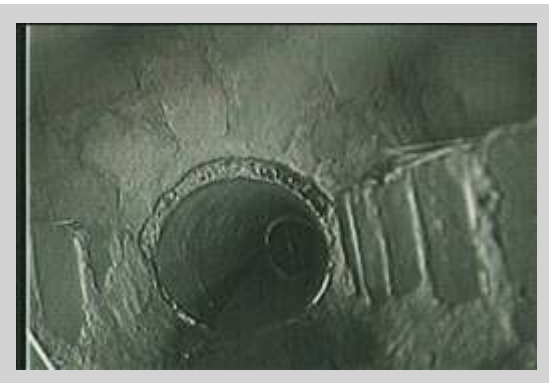
### 6 in. Circular Gravity Sewer Pipe In @ 9 O'Clock

Infiltration: **Evidence** Pipe Seal Cond: **Unknown**
